EROSION CONTROL AND ENVIRONMENTAL RESTORATION

Simandou Range iron ore project, Guinea

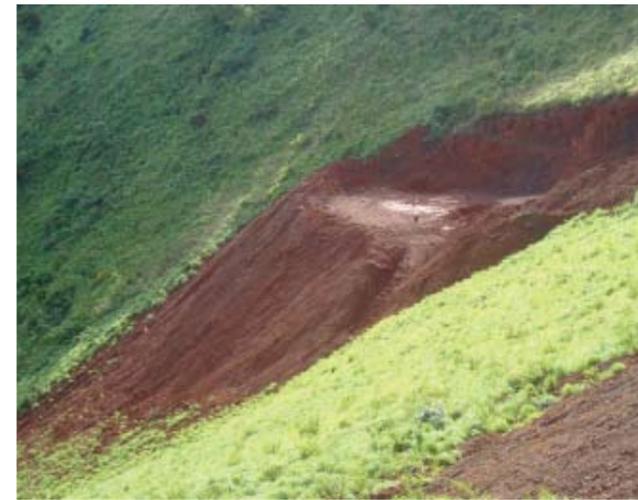
LEFT: Uncontrolled surface water run-off from such disturbed areas was considered the highest environmental risk on the project. It was vitally necessary to prevent sediment from washing into the chimpanzee habitat below.

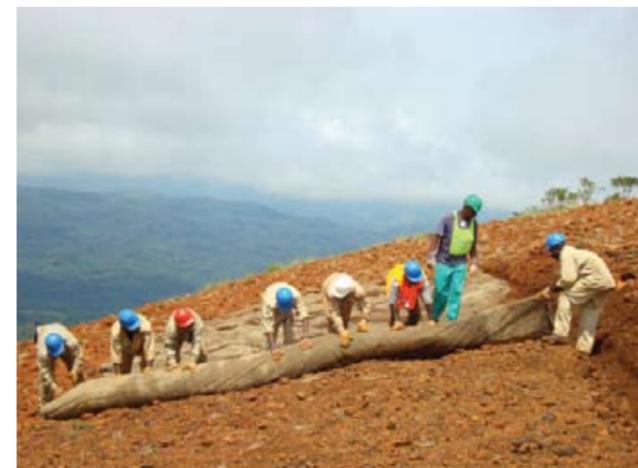
BOTTOM LEFT: Laying Biojute to stop 'splash erosion' and create a microclimate for revegetation.

After the results of the detailed chemical analysis of the various soils on site had been received, decisions were made on how to deal with the problem sites and soil erosion control methods were put in place. The product BioJute, a fabric which biodegrades with time, was chosen to stop 'splash erosion' and to create a microclimate for revegetation. It also serves to retain

surface moisture. Six metre wide strips were fixed in place on the slopes below the platforms of drill pad bases. Several grades of this material were trialled for suitability. A bag stitcher was used to stitch the widths of BioJute together to form continuous 6m wide mats, so as to preclude separation at the edges of rolls. The mat was pegged into the ground with stakes. Wire mesh netting at a width of 2, 8m was used in areas where extra reinforcement was needed.

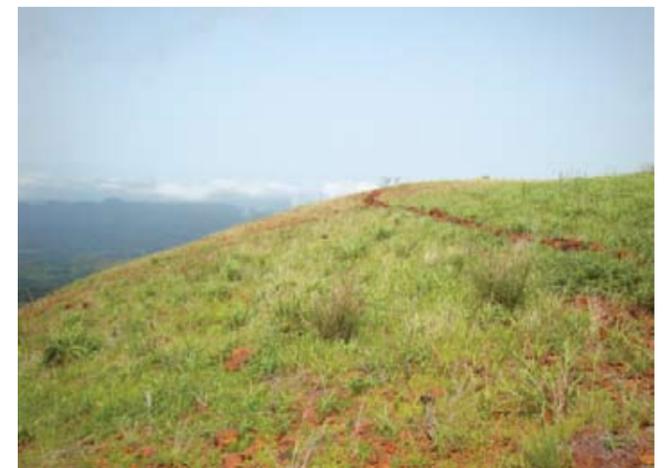
BOTTOM RIGHT: Indigenous grasses coming through in the same area after hydroseeding.

Once the erosion control measures had been installed, Vetiver grass hedgerows were planted and the hydroseeding applications for revegetation were carried out, using hydraulic seeding equipment with a built-in agitation system and a specialised centrifugal pump for handling various viscous and slurry formulations. A 6x6 truck was equipped with a Finn Hydroseeder for this project. In the sensitive mountain areas, locally indigenous grass seed was collected for the seed mix. According to Williams, seeds from grasses found in the Pic de Fon and Oueleba areas of the mountain range that were used on the project were largely *Pennisetum purpureum*, *P. hordeoides*, *Melinis minutiflora* and *Hyparrhenia* species. A commercial seed mix was used for the hydroseeding at Beyla airport.

The seed is combined with a soil binding agent in order to bind the loose soil particles when the mix makes contact with the surface, and along with the mulch and additives to create a suitable microclimate for the germination of the grasses on the steep slopes. Organic matter and fertilisers were added to the hydroseeding mix at application rates determined by the soil analysis. Work was completed by November 2008, and the 6x6 truck and hydroseeding unit was purchased by the mine after the completion of the initial work.

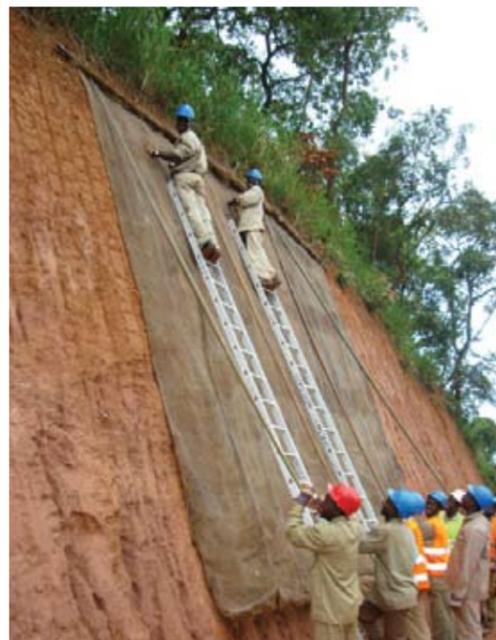
ABOVE: An almost vertical slope being clad with BioJute. Safety is always meticulously taken into account on Rio Tinto's projects.

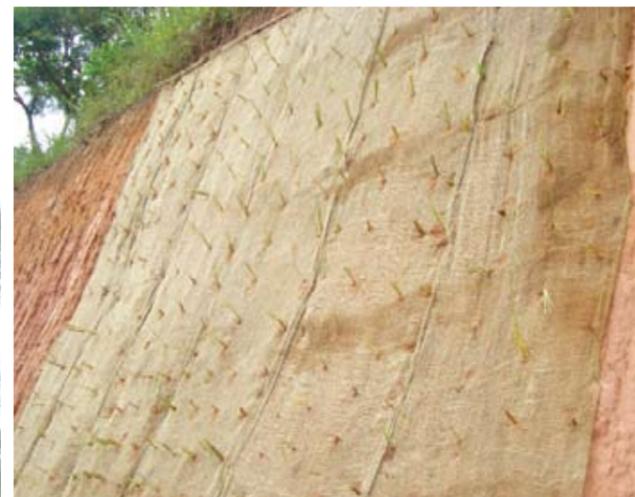
ABOVE CENTRE: Vetiver planted in the BioJute on the same slope.

The outskirts of some of the neighbouring villages proved to be a good source of this plant material which had, historically, been used for the stabilisation of agricultural soils. Although the indigenous West African species, *Chrysopogon* (previously *Vetiveria*) *nigritana*, is found in the area, *C. zizanioides* was approved by Kew because it is sterile. Locals were trained in the sourcing of the best Vetiver material and trimming and collecting techniques, along with methods of splitting the clumps ready for planting. The Vetiver was planted into the BioJute on the slopes of the service roads, behind culvert head walls, at drain outlets and along the breakpoint of fill slopes for additional stabilisation. Nöffke said that Vetiver was used because of its ability to cope with the severe angle of the side slopes and its ability to retain sediment deposition. He commented that hydroseeding with

the veldgrass seeds without this additional precaution would not have resulted in successful grass establishment on the extreme slopes. The Vetiver also served to further anchor the BioJute on the uncompacted fill slopes and steep in-situ cut slopes.

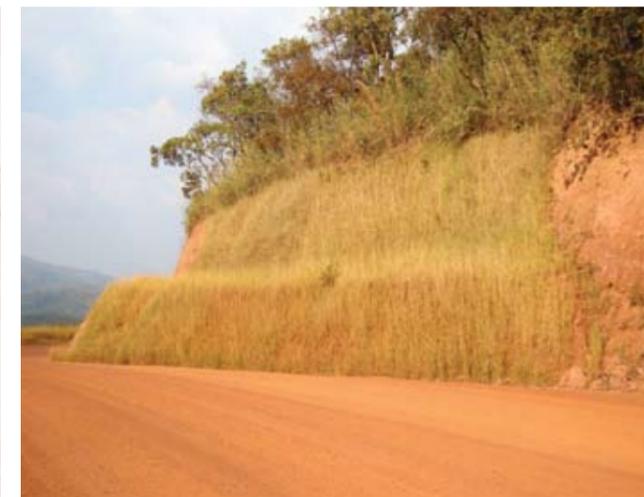
ABOVE RIGHT: Indigenous grass species establishing after hydroseeding on the same steep slope.

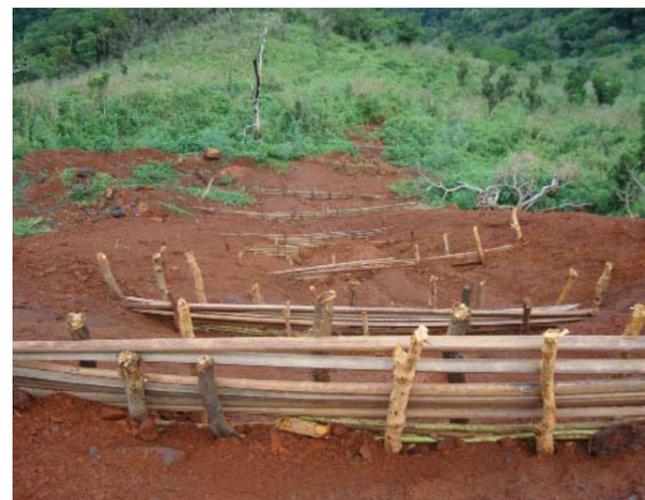
ABOVE: Palm fronds were collected to build 'trash bunds' for soil retention on the steep slopes.

Where necessary, 6m wide 'trash bunds' constructed from locally

collected palm fronds were erected at 20m intervals as an interim measure for soil retention below the Biojute netting – and, according to Nöffke, some of these filled up completely with silt. Lower down the slopes, the additional protection of 20m wide silt fences was required in some areas to contain sediment deposition. Sandbag walls were positioned and secured in side slope gullies and at other sensitive areas of the terrain, such as above the wetlands and on the edges of forest patches, to serve as further retention of sediment deposition. The sandbags were staked with 500mm long steel pegs to reduce slippage. Rock gabions were utilised for stabilisation in certain areas.
